SUBJECT: RCRA Preliminary Assessment - Information Requests

RCRA PRELIMINARY ASSESSMENT
PR/VSI REPORT
SAFCO ENVIRONMENTAL
POST FALLS, IDAHO
EPA I.D. NO. IDD984667469

JULY 1992

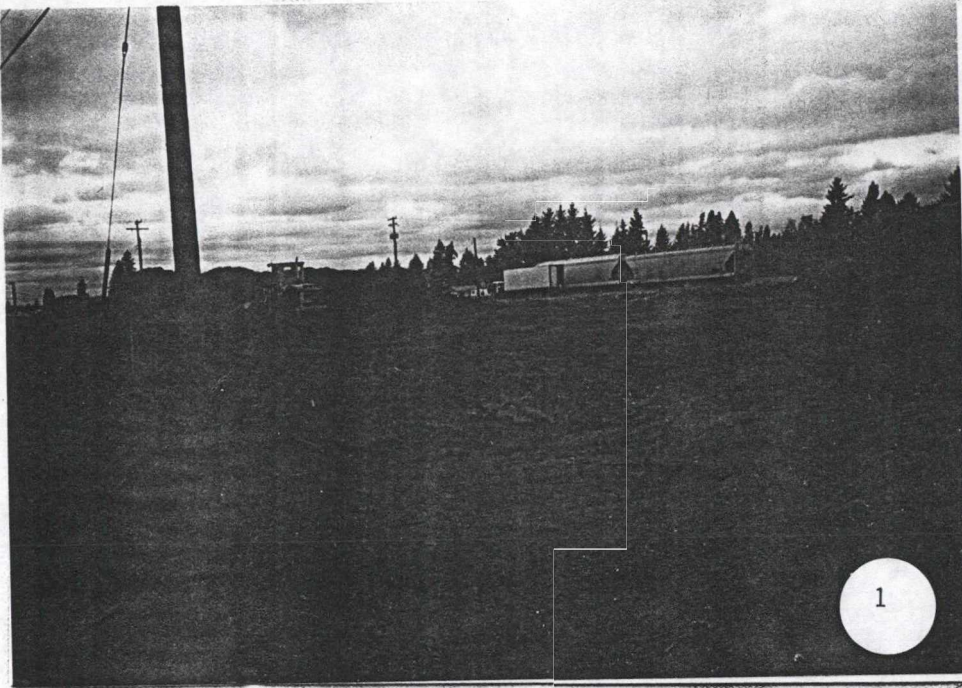
| <u>Photo No.</u> | <u>Description</u> |
|---|---|
| 1. | View of heavy equipment moving cedar debris pile. Taken from the intersection of the dirt road and Post Street (same location as photos 2 and 3), facing northwest. |

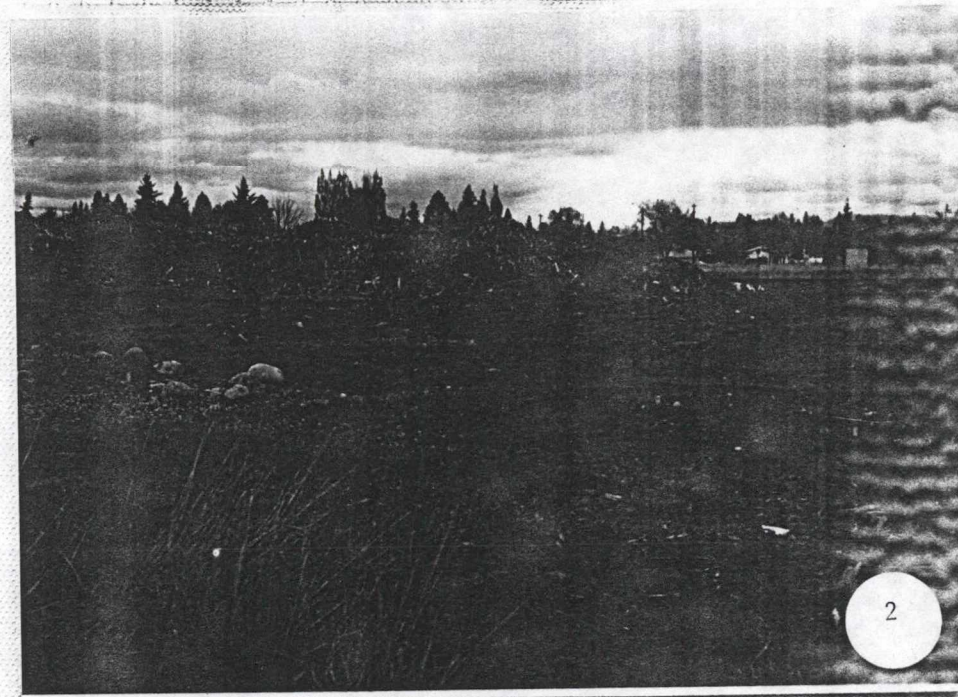
| <u>Photo No.</u> | <u>Description</u> |
|---|---|
| 2. | View of a cedar debris pile. Taken from the same location as photos nos. 1 and 3 (the intersection of the dirt road and Post Street), facing north. |

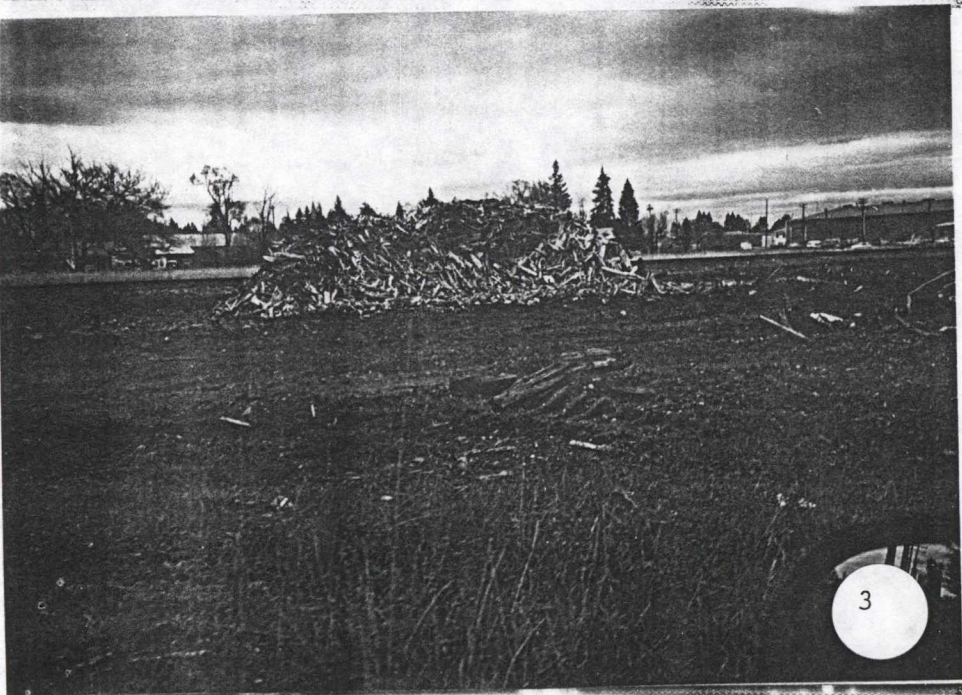
| <u>Photo No.</u> | <u>Description</u> |
|---|---|
| 3. | View of a cedar debris pile. Taken from the same location as photos nos. 1 and 2 (the intersection of the dirt road and Post Street), facing northeast. |

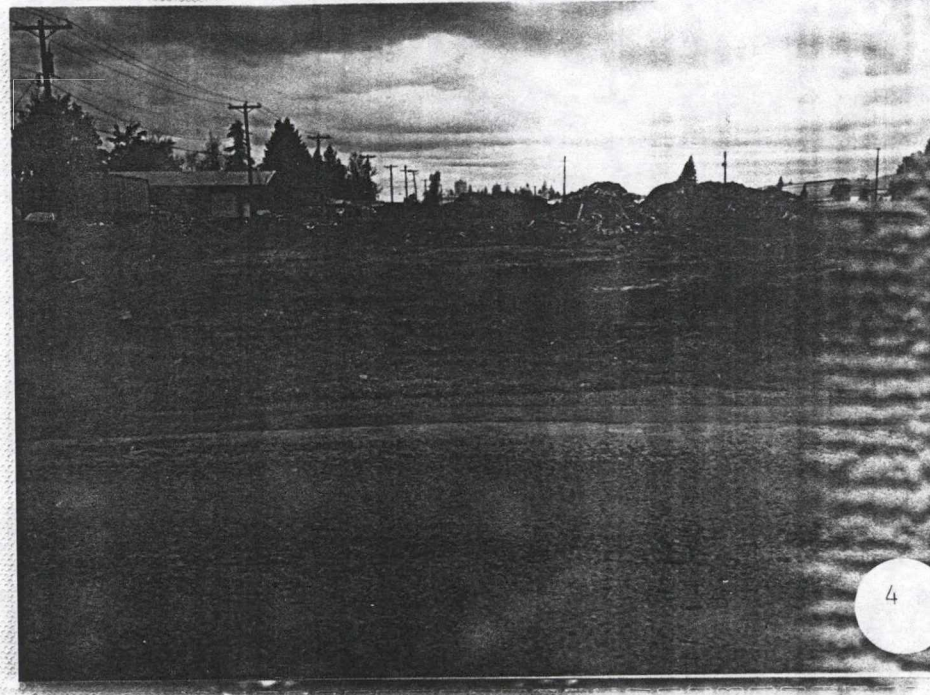
| <u>Photo No.</u> | <u>Description</u> |
|---|---|
| 4. | View of the site (area between the dirt road and the railroad tracks) taken from Lincoln Street, facing west. |

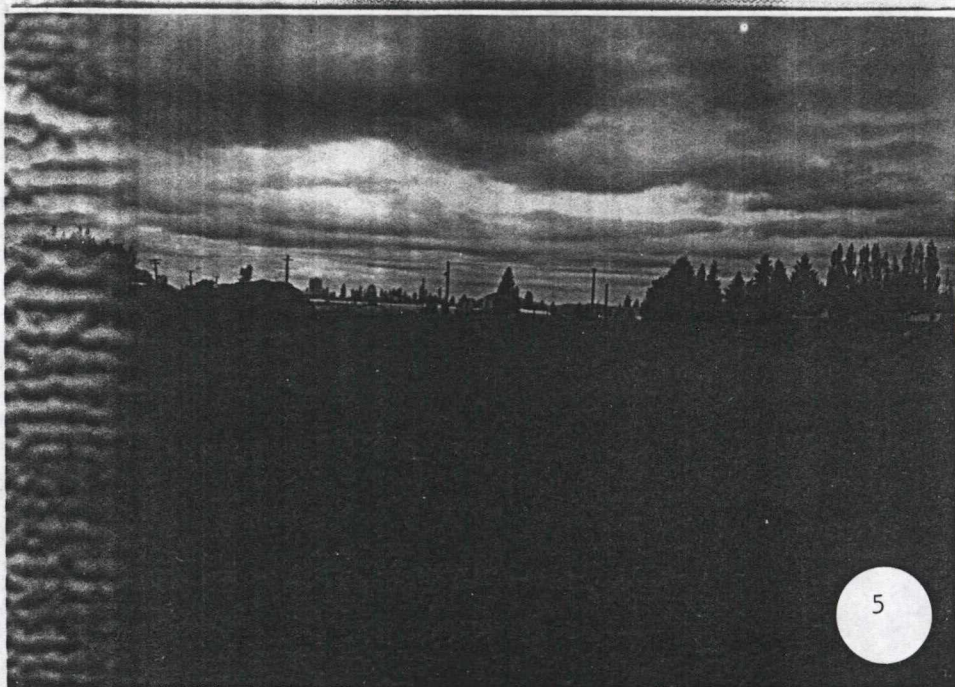
| <u>Photo No.</u> | <u>Description</u> |
|---|---|
| 5. | View of the area between the railroad tracks. The photo was taken from Lincoln Street, facing west. |

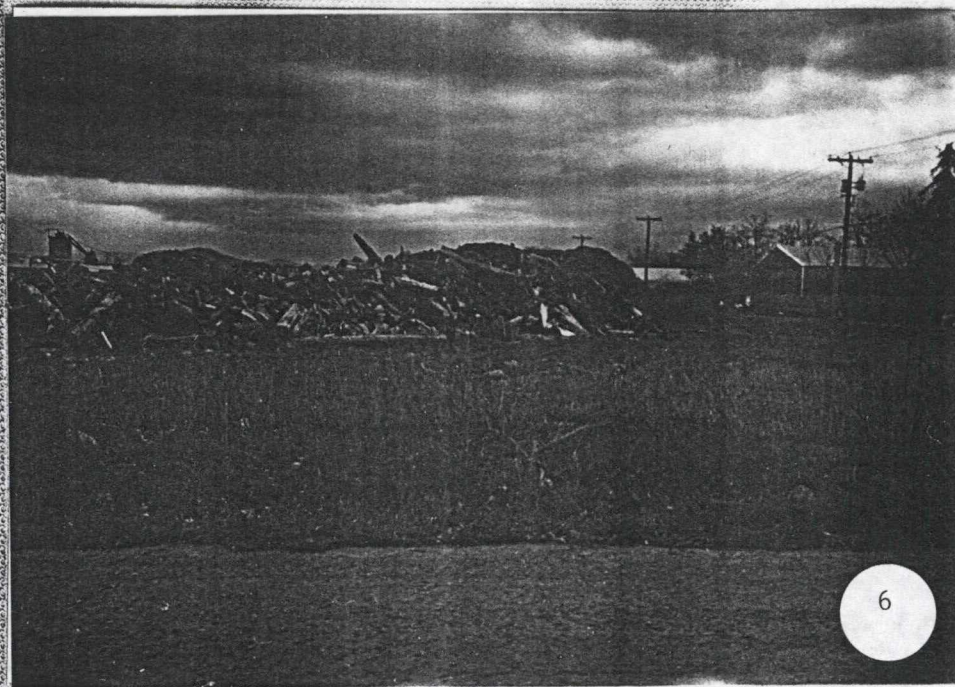
| <u>Photo No.</u> | <u>Description</u> |
|---|---|
| 6. | View of site (area between the dirt road and the railroad tracks) taken from Henry Street, facing east. |

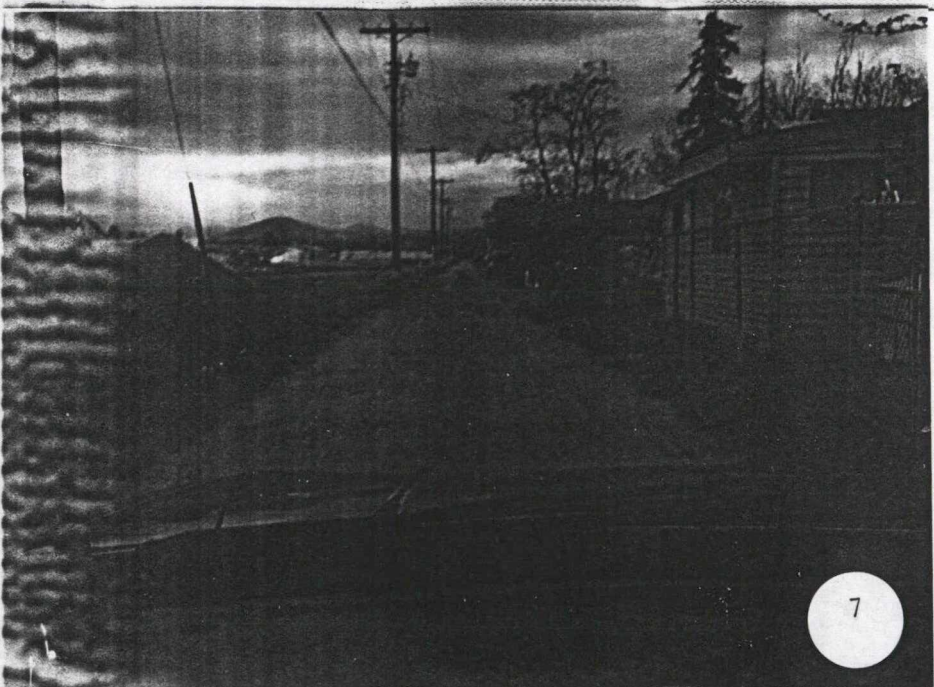
| <u>Photo No.</u> | <u>Description</u> |
|---|---|
| 7. | View of the dirt road taken from near Henry Street on the dirt road, facing east. |

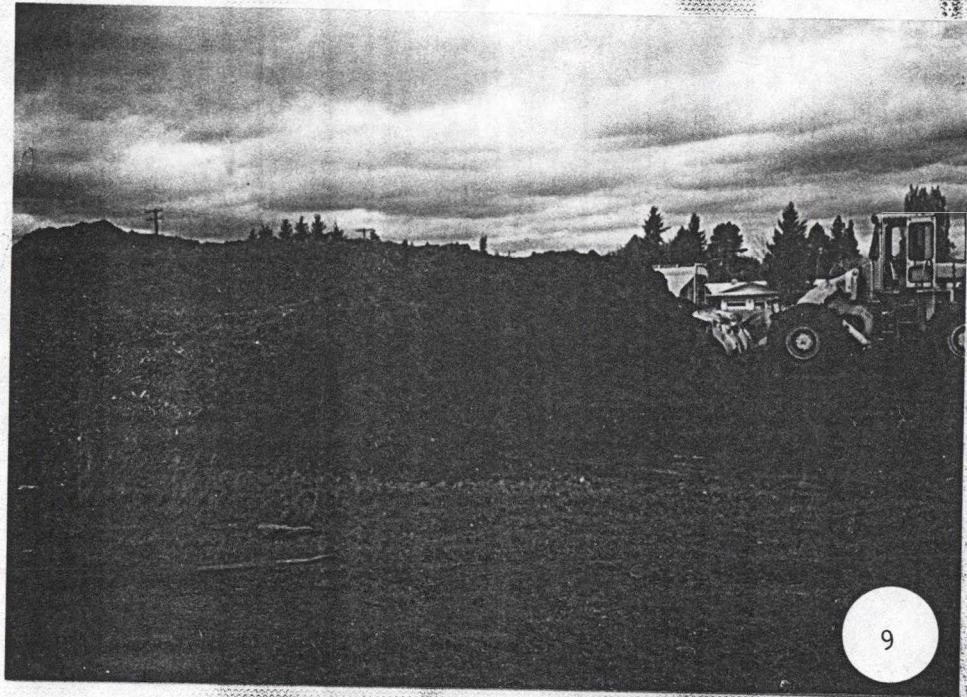
| <u>Photo No.</u> | <u>Description</u> |
|---|---|
| 9. | View of cedar debris pile removal, facing north. Photo taken from dirt road. |

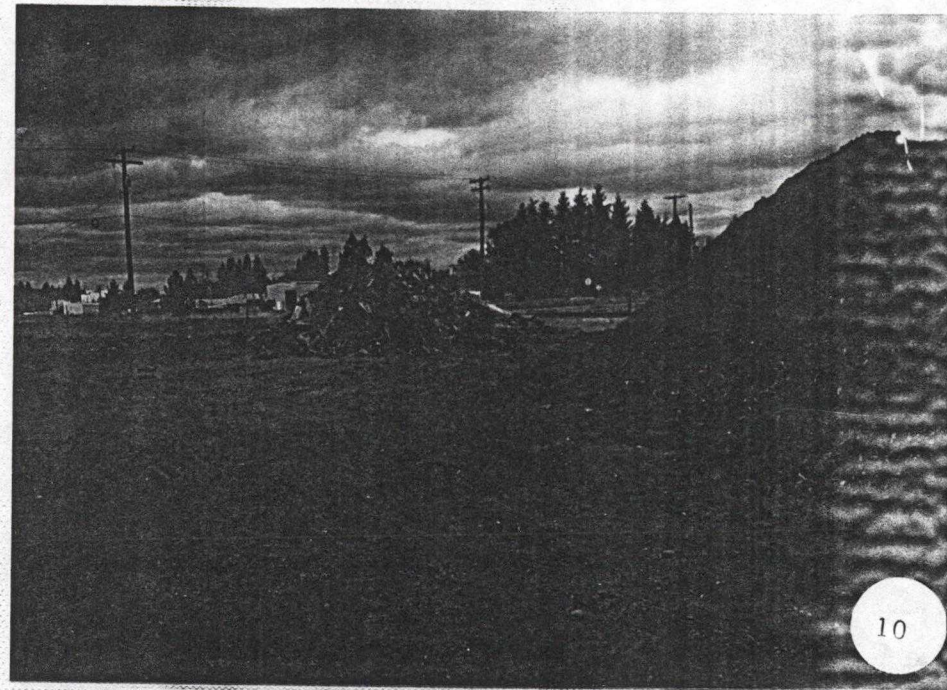
| <u>Photo No.</u> | <u>Description</u> |
|---|---|
| 10. | View of cedar debris pile. Taken from same location as in photo 9, facing northeast. |
